## 1.0 Introduction & Exclusions

1.1 Capital PCC were engaged by Barnet Homes to undertake a desktop analysis and follow-up surveys, in order to establish the nature and extent of combustible cladding to low-rise properties (up to three storeys) within the borough which are believed to be timber framed. The action was prompted following the fire which occurred on the 8<sup>th</sup> of June 2023 and resulted in severe damage to a terrace of four, two-storey houses, resulting in a recommendation for all four houses to be demolished and the subsequent investigation report into the causes of fire spread undertaken by Capital PCC. Although there were no fatalities or serious injuries one householder had to be rescued as they were unable to self-evacuate. As a result, Barnet Homes wished to make an assessment of properties which were at risk of a similar occurrence, with a review of potential preventative measures.

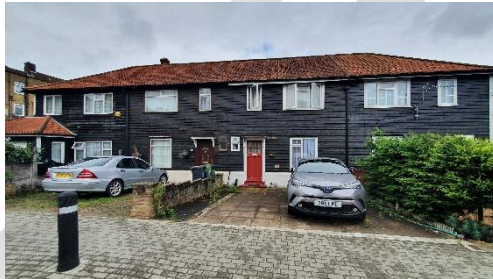
1.

Timber clad, timber framed

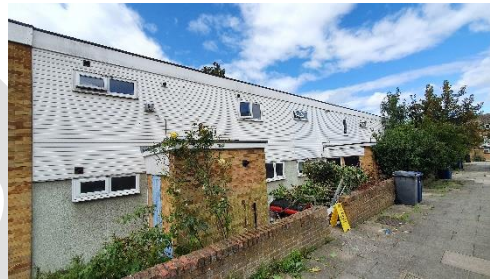
2.

UPVC clad, timber framed

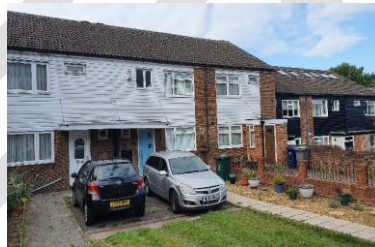
Type 2 - 1970's UPVC/ timber clad & brickwork

50 units

8.2.5 Remediation of Type 2 could be limited to the replacement of the cladding, soffits and fascia's only, due to the limited areas this would not fall under the rule for the requirement of a thermal upgrade, however other works to ensure the continuation of the vertical line of compartmentation would be required e.g. cavity barrier at the party wall line and fire stopping within the eaves.

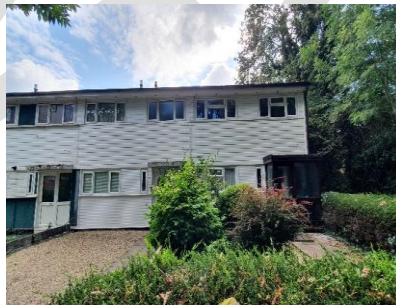
Type 3 - 1970's UPVC/timber sheet cladding

10 units

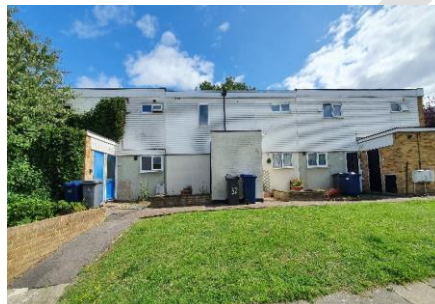
Type 4 - 1970's UPVC / sheet cladding with flat roof

59 units

5.7.2 At the vertical compartment party wall line, the outer wall consists of a continuation of the timber framed, external wall arrangement so there is effectively no fire break arrangement within the external wall between separate units.

5.7.3 As the Type 4 archetype have flat roofs there is no traditional eaves detail but instead a continuous UPVC fascia board which covers the junction between the head of the external walls and the roof. Directly behind the UPVC fascia board there is a continuous cavity which offers an unrestricted route for the spread of fire from one unit to another.

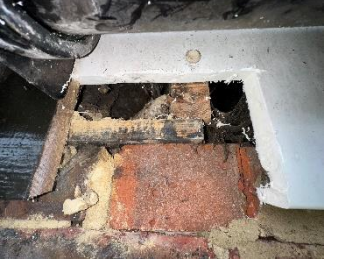
<p data-bbox="1166 1549 1518 1675">Junction of party wall behind the fascia, there is a continuity gap which should be fire stopped</p>

5.5.3 It was noted that the dividing party walls in the roof-spaces appeared to meet the underside of the roof covering without any significant gaps noted. However, at eaves level behind the fascia boards, gaps in the fire stopping continuity were noted.

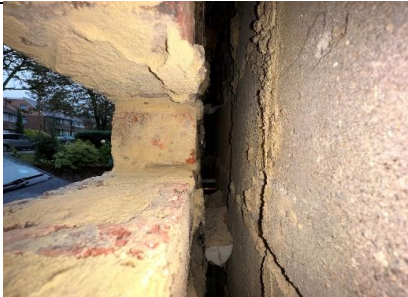
5.6.1 None of the properties so far investigated had any insulation within the walls. The masonry cavity wall was opened and this revealed no cavity wall insulation present and limited amounts within roof spaces.

Masonry wall with empty cavity 70mm

This gives an opportunity to upgrade the thermal performance of the houses by installing cavity wall insulation of up to 70mm depth in the walls; loft spaces could also be considered for upgrades. Separately or combined, the insulation upgrades will have an impact on both the thermal performance and associated EPC scores. However, with this archetype Building Regulations would not require an insulation upgrade to the walls as part of any cladding remediation due to the limited area of wall covering affected.

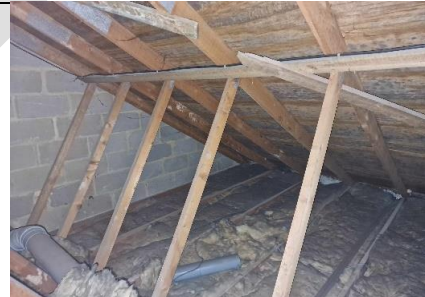
Loft insulation 100mm

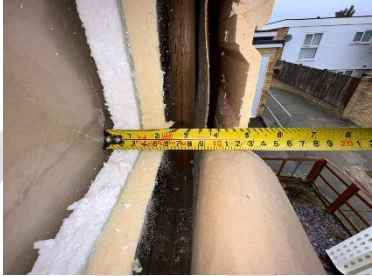
Wall build-up, upper floor front

5.7.1 Investigations into selected limited locations, revealed that the properties are of timber framed construction with external continuous UPVC cladding fixed to the upper floors and a mixture of gravel dashed fibre reinforced resin / plastic sheet cladding to the lower floor at the front and a cement particle cladding sheet board to lower floor at the rear. There is also a mix of insulation types within the walls comprising of EPS sheets, thermoset foam sheets and loose fill mineral wool, the insulation types only partially fill the void within the timber framed walls.

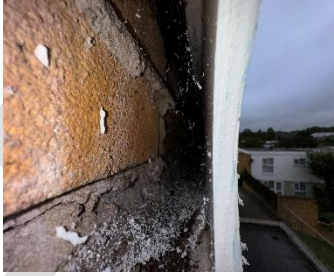
UPVC fascia with continuous cavity behind

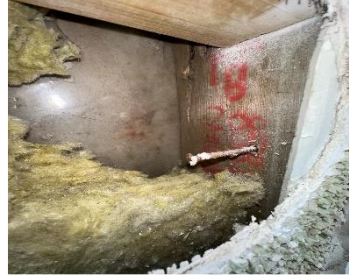
Wall build-up, lower floor front

5.8.2 The lower section walls contain 50mm loose fill mineral wool fibre insulation.

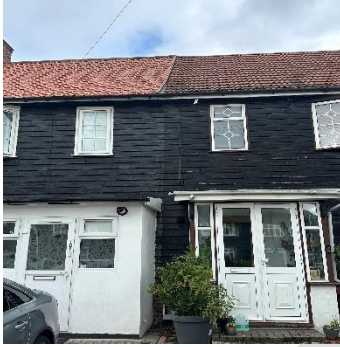
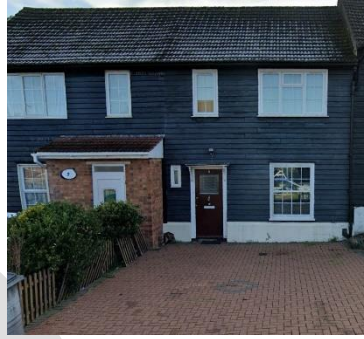
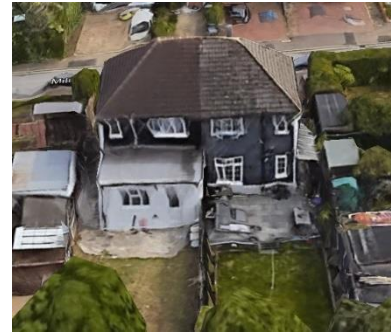
8.4.2 However from a technical & buildability perspective, this potential option is unlikely to be feasible as a universal solution as many of the houses have porches to the front and / or rear extensions which are built right up to the party wall line and such arrangements will prevent any extension of the party wall being brought forward as a fire break.

8.4.3 Works could be carried out externally, however likely to be technically unviable.
