## 1.0 Introduction & Exclusions

1.1 Capital PCC were engaged by Barnet Homes to undertake a desktop analysis and follow-up surveys, in order to establish the nature and extent of combustible cladding to low-rise properties (up to three storeys) within the borough which are believed to be timber framed. The action was prompted following the fire which occurred on the 8<sup>th</sup> of June 2023 and resulted in severe damage to a terrace of four, two-storey houses, resulting in a recommendation for all four houses to be demolished and the subsequent investigation report into the causes of fire spread undertaken by Capital PCC. Although there were no fatalities or serious injuries one householder had to be rescued as they were unable to self-evacuate. As a result, Barnet Homes wished to make an assessment of properties which were at risk of a similar occurrence, with a review of potential preventative measures.

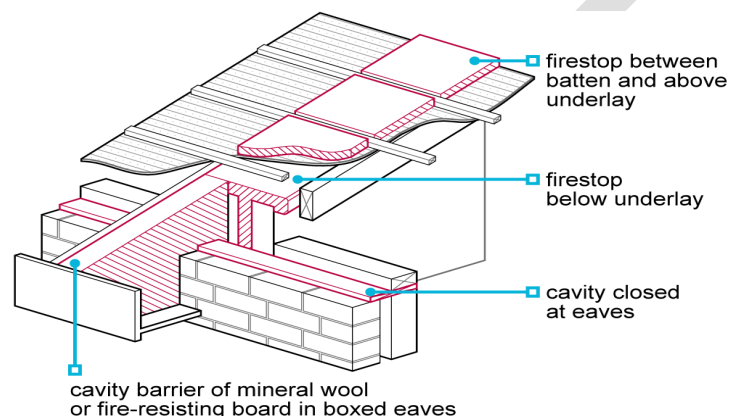
1.2 The Capital report into the fire at Moss Hall Grove highlighted that the most likely causes of the rapid fire-spread were via the combustible external cladding material which bridged across the compartment lines between houses, via the boxing-in of the roof eaves and potentially between the head of the compartment party wall and the underside of the roof covering. In modern construction these potential routes at roof level would be designed out as per guidance e.g. [NHBC detail 7.2.16](#)
